NASA CR-2549

DESIGN AND FABRICATION OF COMPOSITE WING PANELS CONTAINING A PRODUCTION SPLICE

D. L. Reed

Prepared by GENERAL DYNAMICS Fort Worth, Texas for Langley Research Center 19960223 063

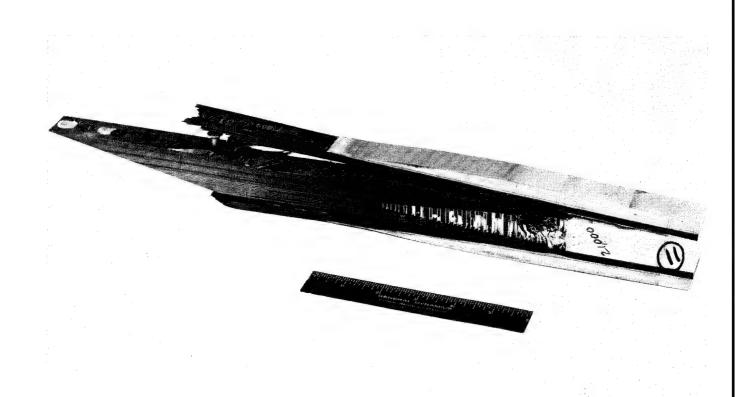
Figure 17 Static Compression Specimen End Grip Failure

Figure 17 shows that a compression specimen that failed prematurely in the end grip region at 93.4 kN (21,000 pounds) compression. The failure initiated at the front end of the solid fiberglass block. In this first test, the grips extended beyond the fiberglass block and the core was crushed. In the second test, when the end of the grips were placed exactly at the end of the fiberglass block, the specimen failed similarly at 87.2 kN (19,600 pounds) compression. A tension specimen which was tested next failed at 85.4 kN (19,200 pounds) tension. 18 shows that this failure also initiated at the front edge of the fiberglass block. At this point it became obvious that the fiberglass block was transferring a significant amount of load and causing a large stress concentration at the front edge of the block. In first attempting to alleviate the problem, a pin was put through the end grip in the core region. The end grips were then placed on the pin and a load applied before the end grips were tightened. This in effect takes a portion of the load around the problem area. The unfailed

pieces of two previous compression specimens were put together and loaded in the manner just described. Failure occurred in the same place at 106.8 kN (24,000 pounds) compression.

first occurred in the development tests (Section 3.5.1), the solid fiberglass block was replaced with intermittent strips of fiberglass (see Figure 31).

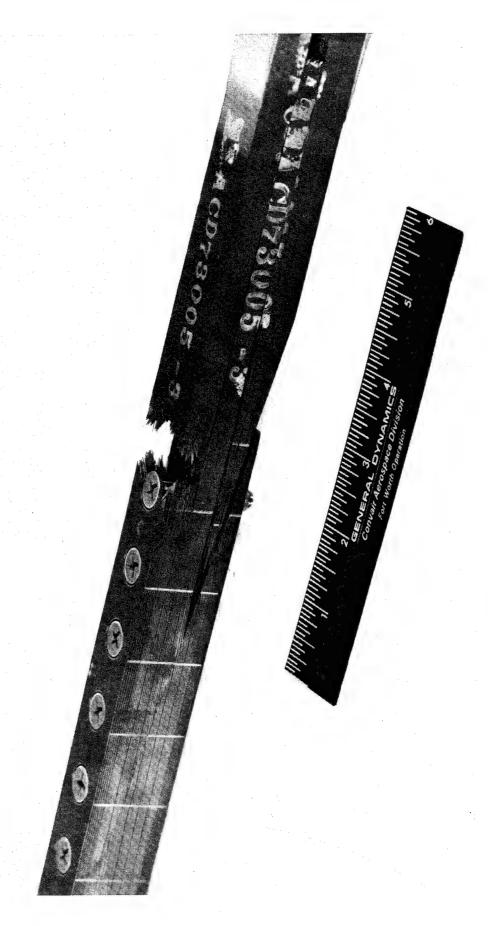
Figure 20 Static Tension Failure

During the static tests, the relative displacement between the two pieces of the splice specimen was recorded with a clip gage. Figure 19 shows a typical curve obtained from a tension splice specimen. In general the first large discontinuity was called failure. If a specimen did not fail catastrophically at the first large discontinuity in the curve, the point of discontinuity was called failure. A typical static failure of a tension splice specimen is shown in Figure 20.

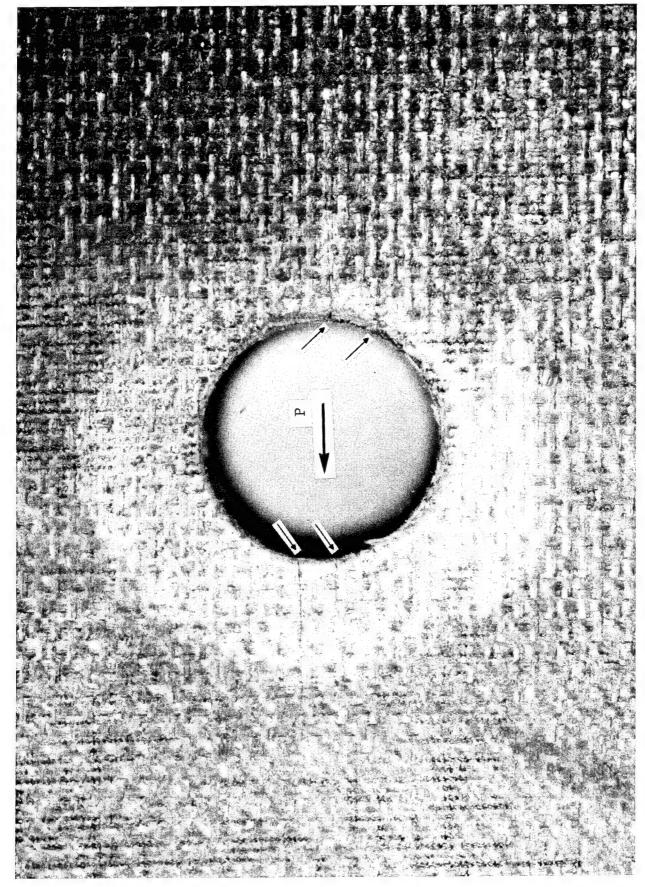
Static Failure Mode in 22

The relative displacement between the two pieces of the joint was also monitored during the compression tests. Figure 21 shows a typical load versus displacement curve. The first successful compression specimen test was taken to a loading of 134.3 kN (30.200 pounds) or 1.34 times design ultimate. load cell being used in the test fixture was only calibrated to 133.4 kN (30,000 pounds) so loading was halted at this point. Since this load level was near the shear capacity of the bolts, it was anticipated that the ultimate failure of the joint would be complete shearing of all bolts. An inspection of the load deflection plot (Figure 21) indicated a significant slope change at 100.5 kN (22,600 pounds). The specimen was removed from the test fixture and the holes inspected. Figure 22 shows splitting cracks in front of and behind the end bolt in the load direction. Since splitting was the critical failure mode, failure was defined as the load at the change in slope.

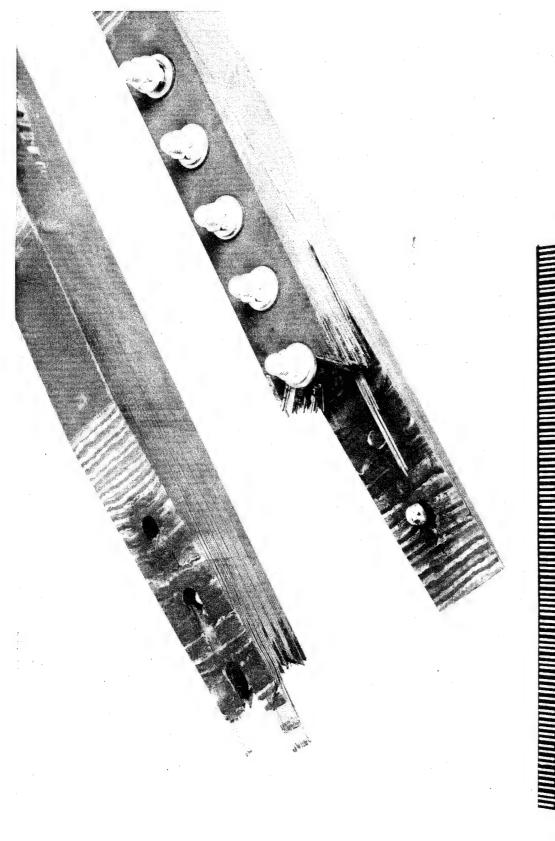
Figure 24 Tension Fatigue Failure at 0.465 Lifetimes

The five tension specimens were tested first. Two specimens failed catastrophically at 0.465 and 0.670 lifetimes. these failed specimens is shown in Figure 24. The tests of the three remaining specimens were continued until 0.854 lifetimes when the test monitor heard a bolt snap in one of the specimens. This particular test was stopped and the specimen inspected. Two bolts were found to be broken and all the bolt holes in the specimen were damaged. The two broken-bolt holes were elongated by approximately 10 percent. Thus, the bolts probably broke in bending fatigue due to the excessive clearances. Figure 25 shows an X-ray radiograph of the two broken-bolt holes in each part of the splice, viewed from the inner surfaces. of the fatigue damage is indicated by the dark areas around the The dark areas were made by applying an opaque liquid holes. die (tetrabromoethane) to the damaged area around the bolt holes prior to X-raying the specimen. The liquid die propagated into the cracks and delaminations by capillary action, causing the damaged areas to show up as dark zones. This NDE method is described in more detail in Reference 4. The specimen was considered to be failed and the test terminated at this point because of the large amount of damage. Based on these observations, fatigue failure of the remaining specimens (tension and compression) was set at first bolt failure. Testing of the last two tension specimens was continued and the fatigue lifetimes for first bolt failure are given in Table III. The broken bolts were replaced in these last two specimens and testing was continued. The joints eventually failed in net tension at an average lifetime of approximately 40 percent longer than the Figure 26 shows one of these last time to first bolt failure. two specimens after final failure. It should be noted that the 40 percent difference in life between first bolt and final failure was obtained with the highly magnified spectrum (1.7727).

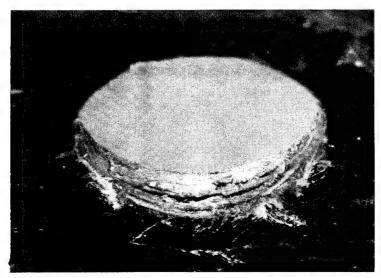
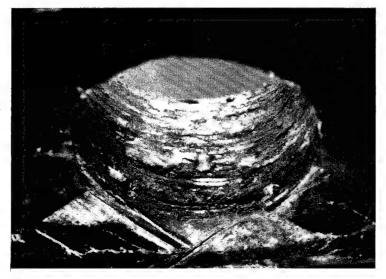
Figure 27 Tension Splice Damage at 4.010 Lifetimes

Side View Showing Longitudinal Crack

Thin End Countersunk Hole - View From Inside Scarf

Thin End Hole - View From Inside Scarf
